July 7, 2023

Mr. Nate Solis
Fisher Heck Architects
915 South St. Mary's Street
San Antonio, Texas 78205

**RE: Limited Asbestos Inspection and
Limited Lead-Based Paint Renovation, Repair, and Painting (RRP) Survey
Live Oak Courthouse
301 Houston Street, George West, Texas 78022
CEI Project N^o: 18286**

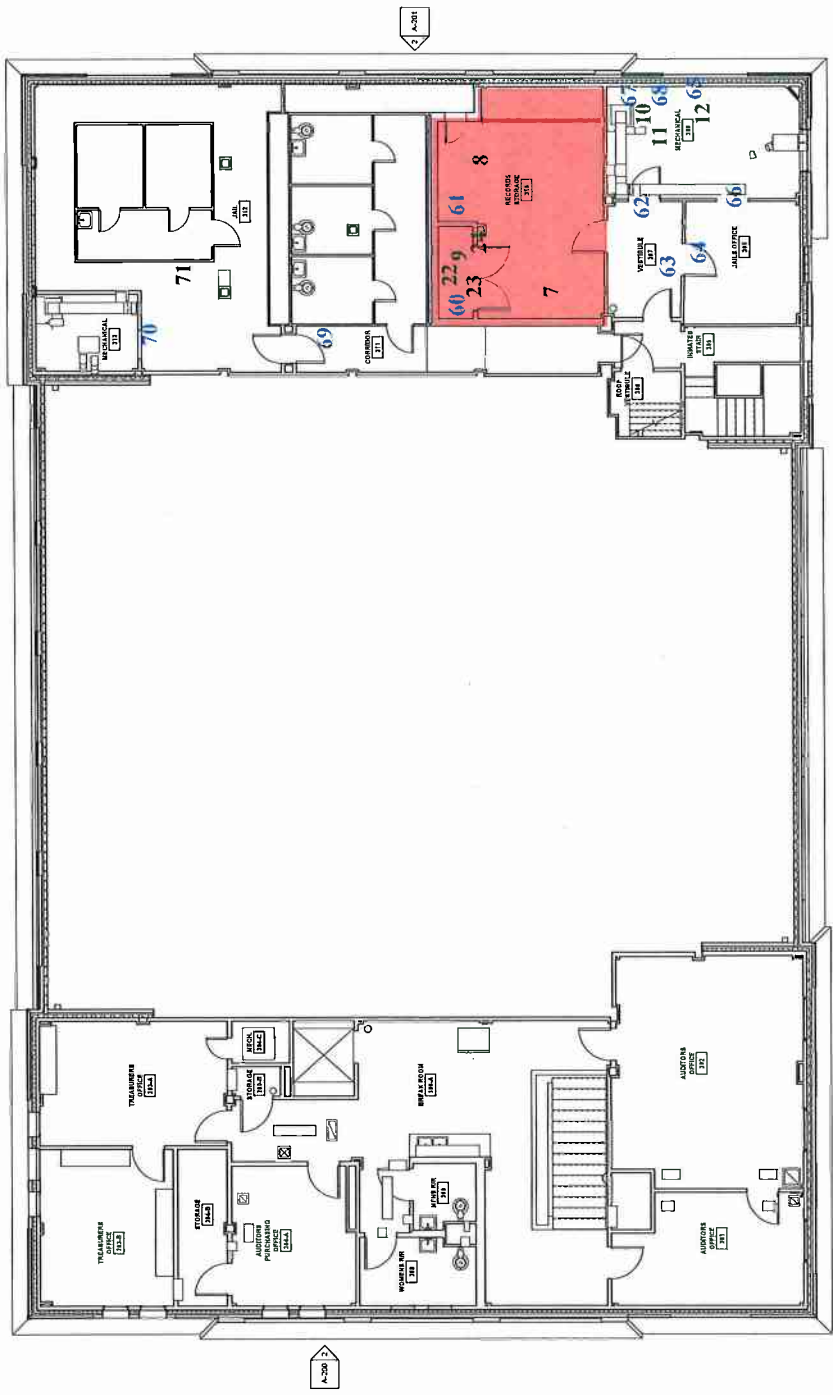
1 THIRD FLOOR PLAN
 20' x 10'

- # Approximate Location of Suspect Asbestos Sample Collected 06-08-2023
- # Approximate Location of Suspect Asbestos Sample Collected 06-08-2023
- Location of Confirmed Asbestos-Containing Material 9x9 Vinyl Floor Tile/Black Mastic

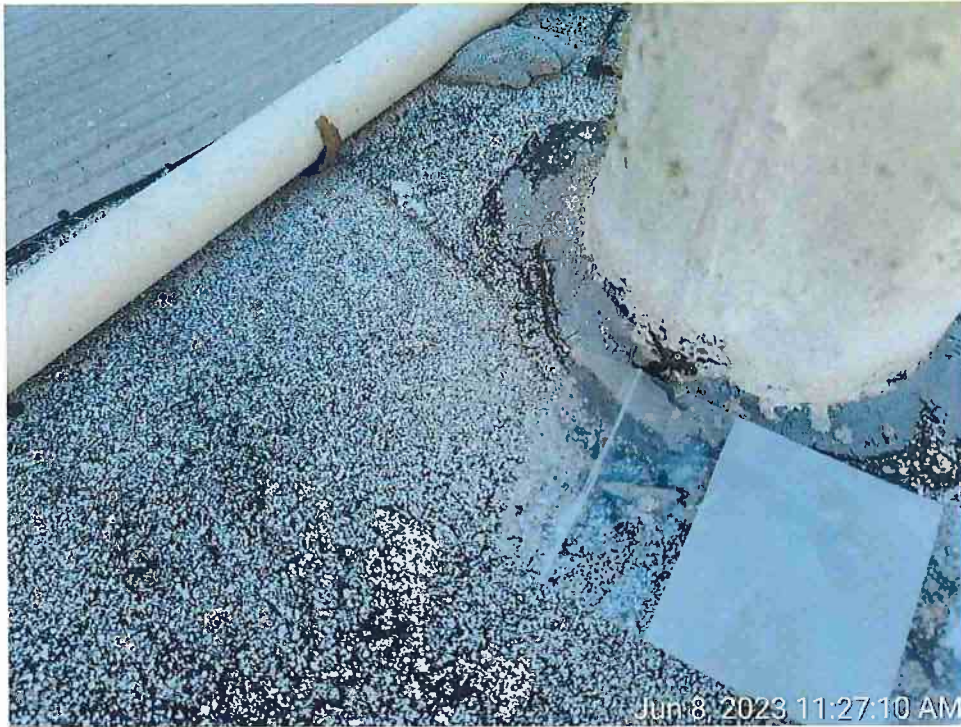
3. View of a roof penetration mastic sample

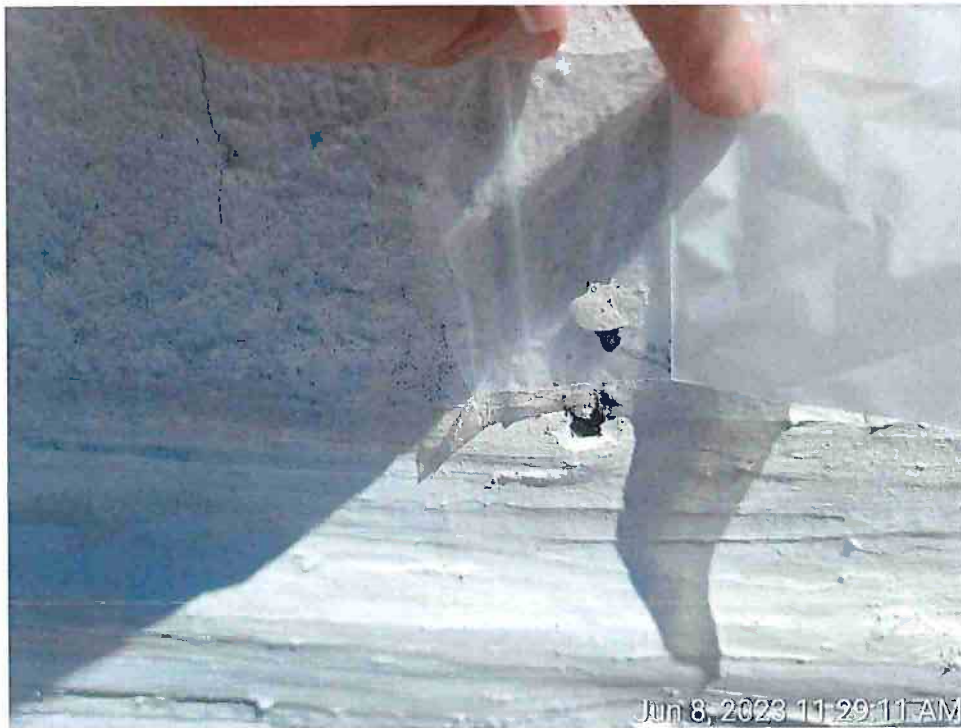
4. View of a Roof Flashing Mastic Sample

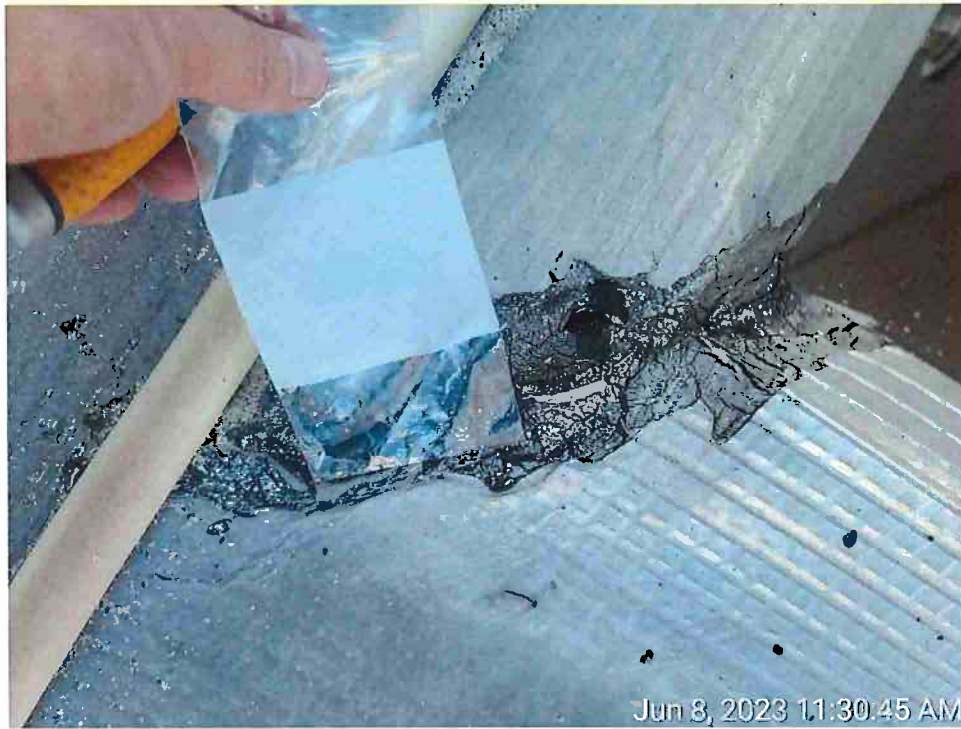
5. View of a Rolled Asphalt Roof Mastic Sample

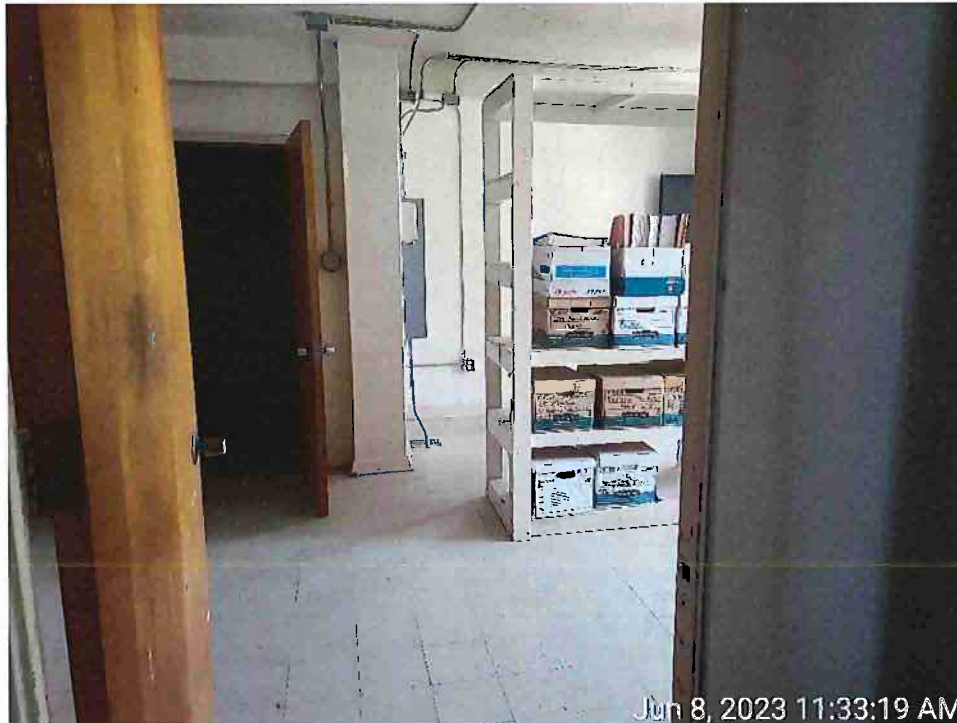
6. View of the 3rd Floor Records Room

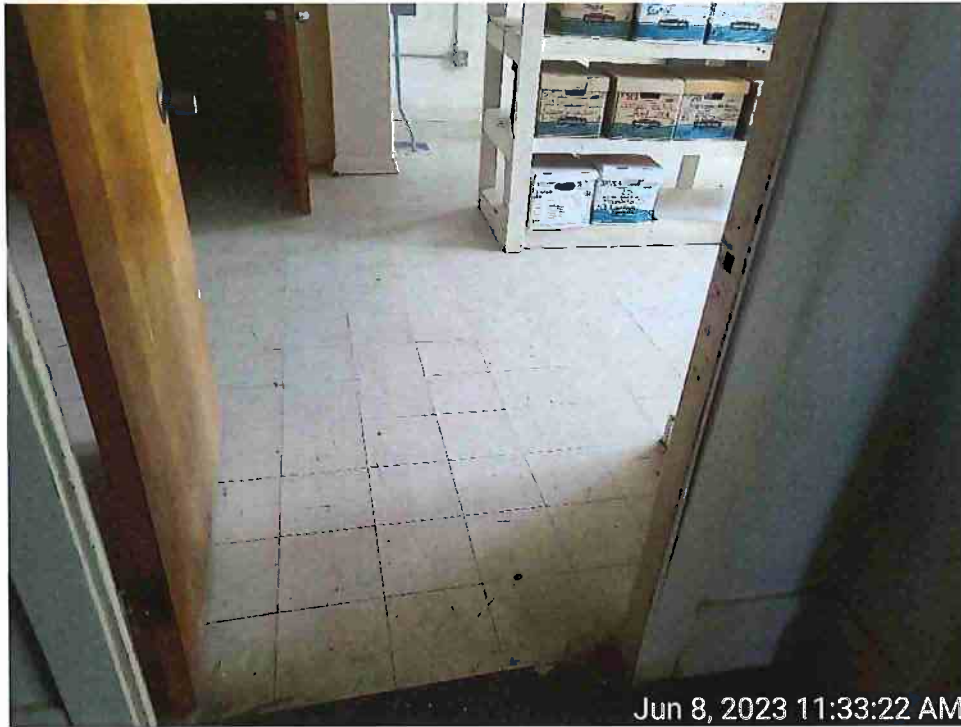
Laboratory analysis indicates that the 9 x 9-inch white vinyl floor tile (8%) adhered with black mastic (5%) identified in the Records Room on the 3rd Floor is positive for Chrysotile asbestos fibers. There is approximately 312 square feet of 9 x 9-inch vinyl floor tile/black mastic in the Records Room on the 3rd Floor. This footage should not be used for bidding purposes and must be verified by a licensed contractor.

7. View of the asbestos-containing 9 x 9 inch White Vinyl Floor Tile adhered with Black Mastic identified in the Records Room on the 3rd Floor

The vinyl floor tile/black mastic **must** be removed prior to any operations that may disturb the asbestos fibers in the material. Abatement must be accomplished according to the guidelines set forth in 40 CFR 61, the National Emission Standard for Hazardous Air Pollutants (NESHAP) and/or DSHS, Texas Asbestos Health Protection Rules, March 2003. This includes removal by a licensed asbestos abatement contractor and project management by a licensed asbestos consultant firm.

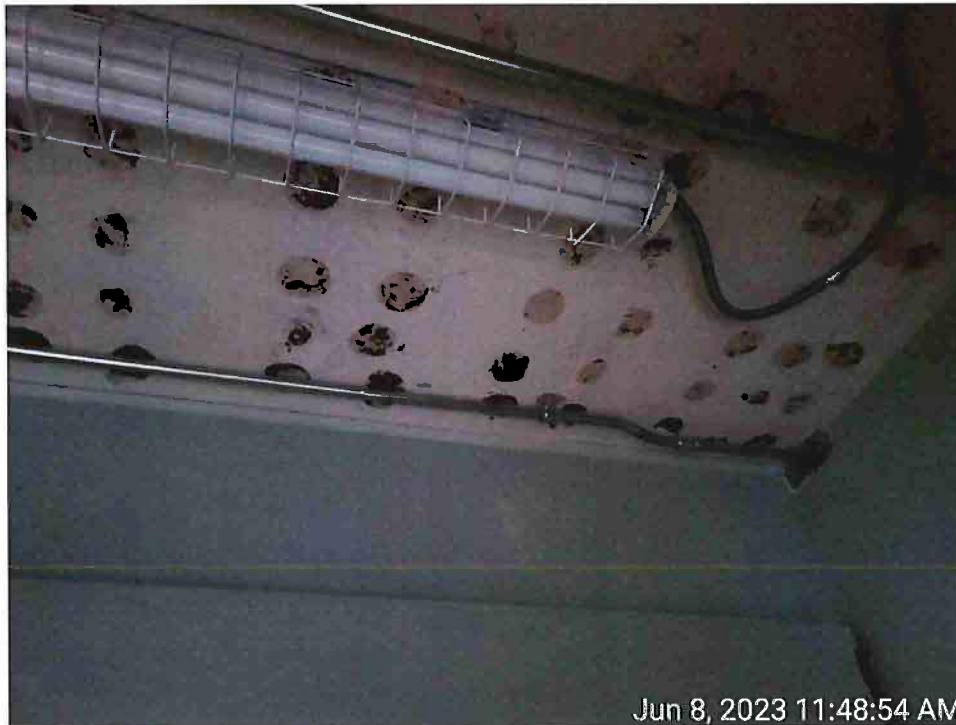
8. View of the exposed brown hockey pucks on the ceiling in the 3rd Floor Closet negative for asbestos.

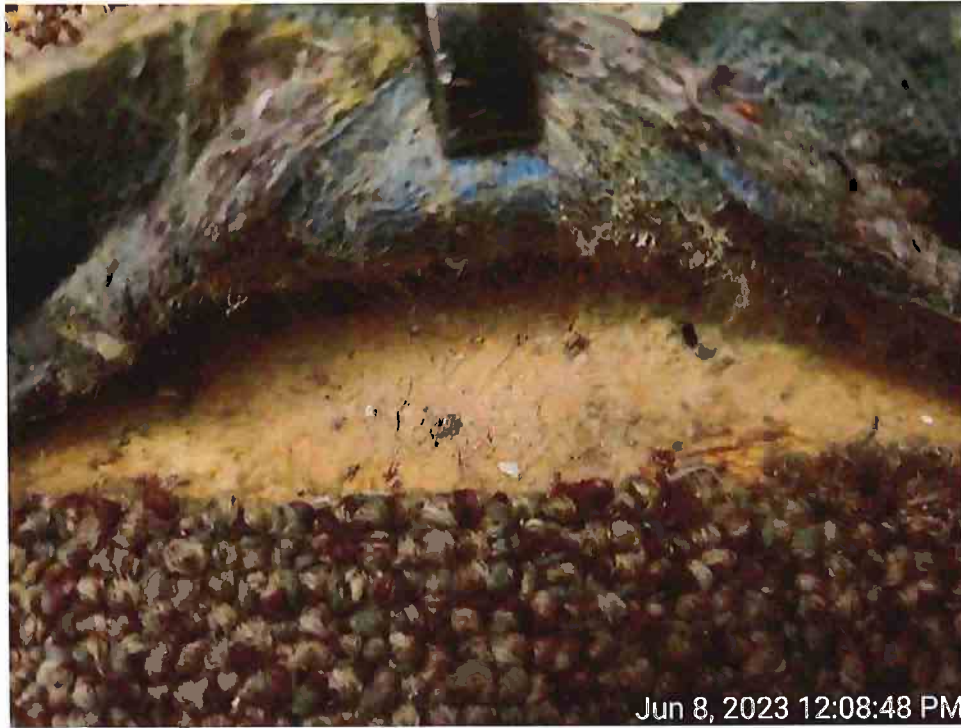
9. View of wood decking identified underneath the carpet in the Court House

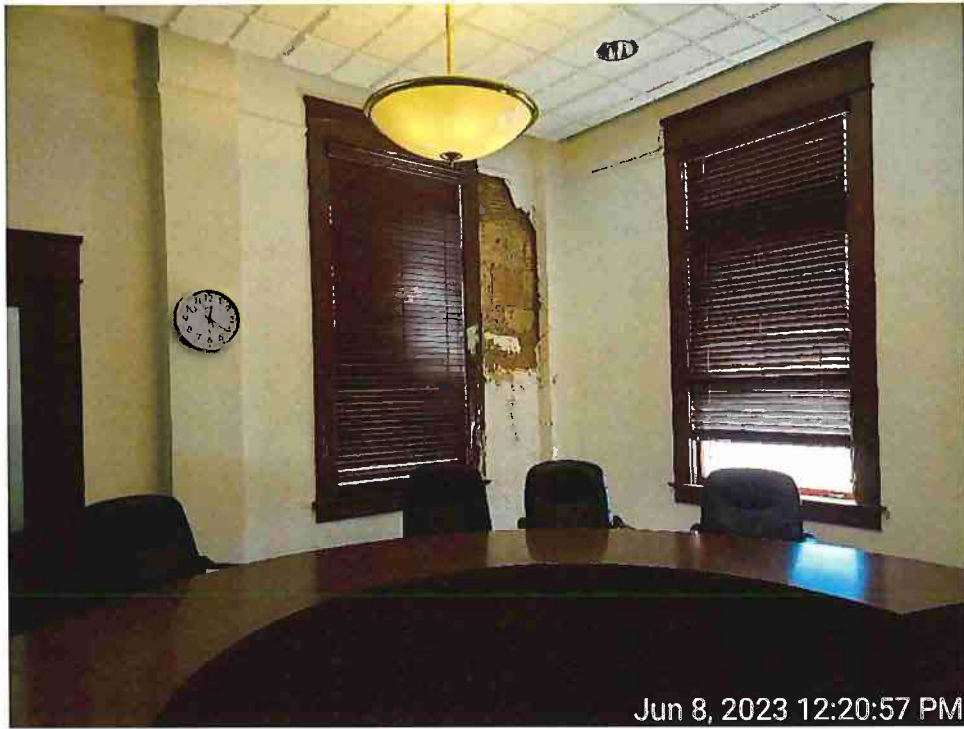
11. View of the Plaster Wall sampled in Room 101

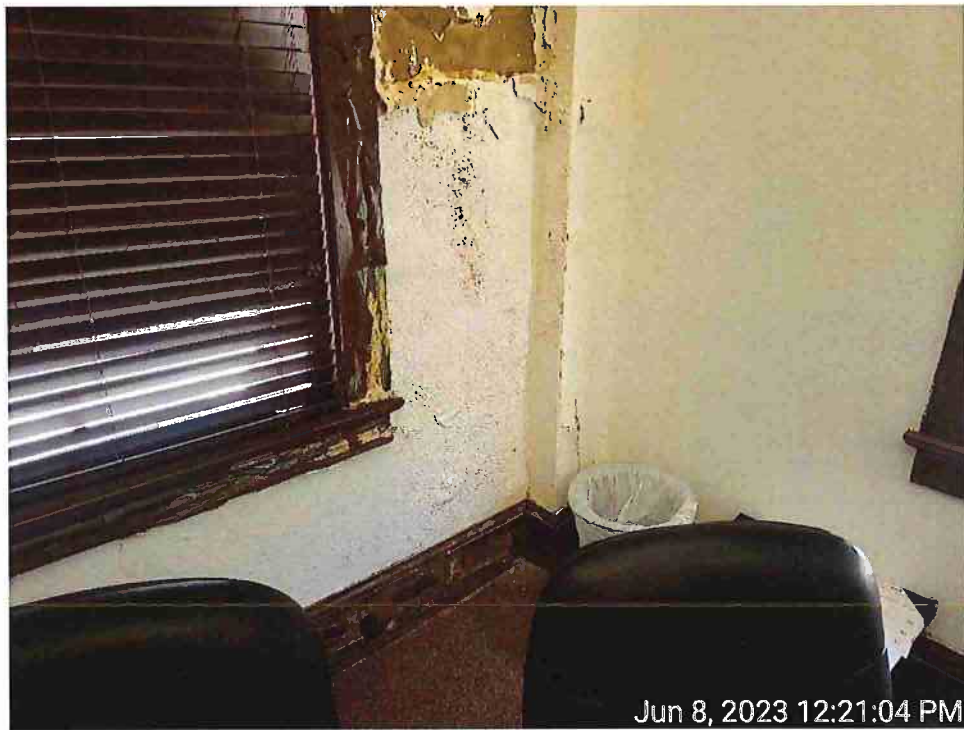
12. View of the Plaster Wall sampled in Room 101

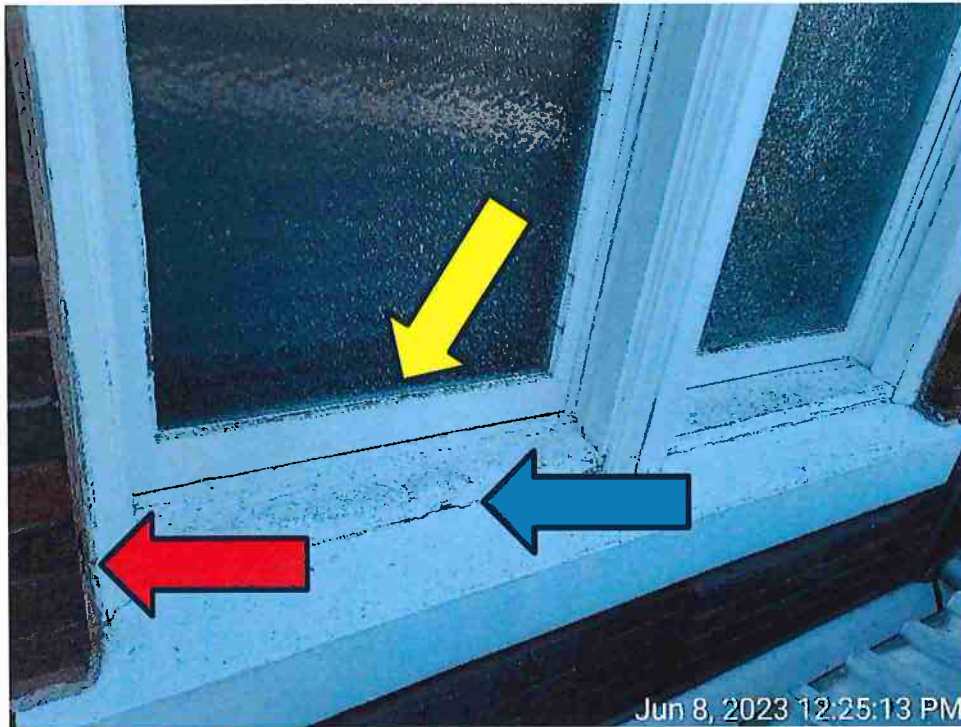
13. View of the samples collected. Red arrow indicates Red Exterior Brick Mold Caulking. Blue arrow indicates Exterior Window Frame Caulking. Yellow arrow indicates Exterior Window Caulking.

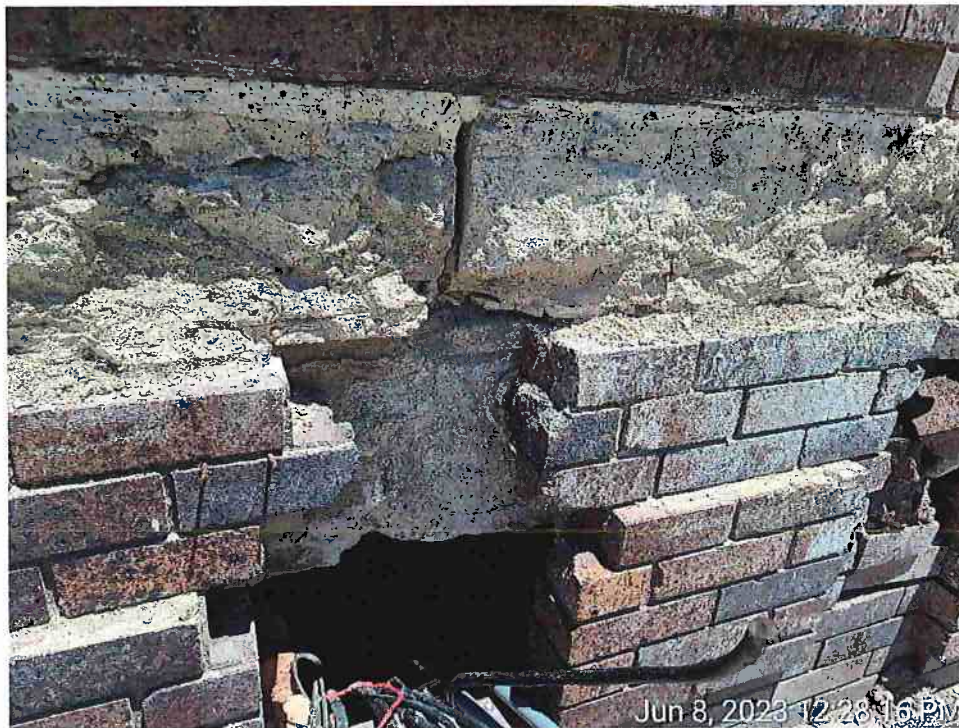
14. View of the removed brick on the exterior of the Building No Barrier Mastic Identified on the exposed Walls, Assuming Uniform Throughout

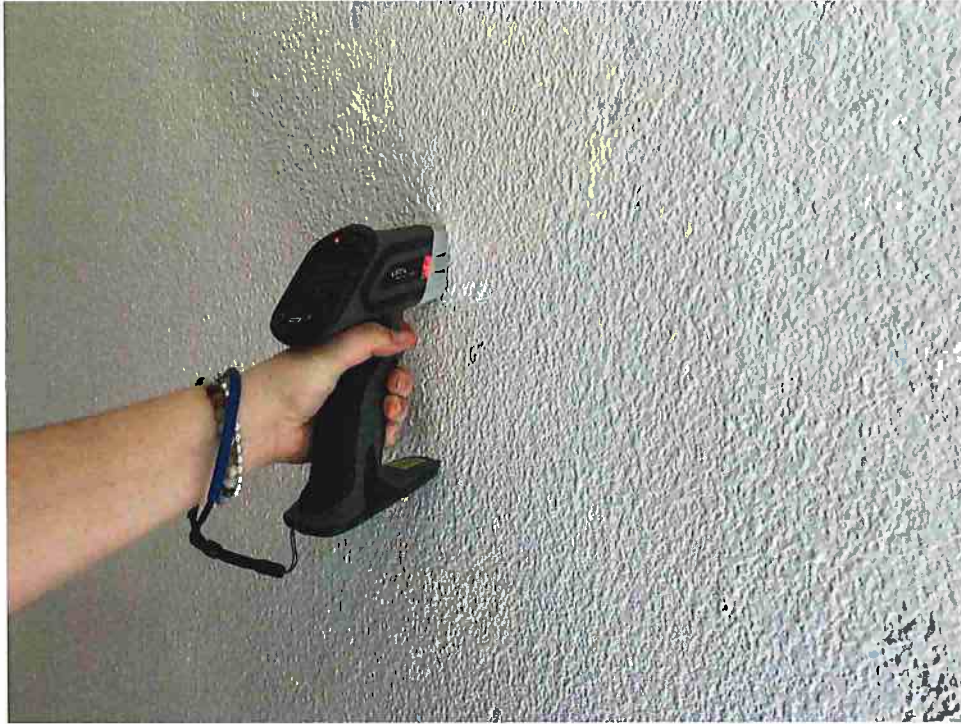
15. Typical view of the white plaster wall being tested for Lead-Based Paint

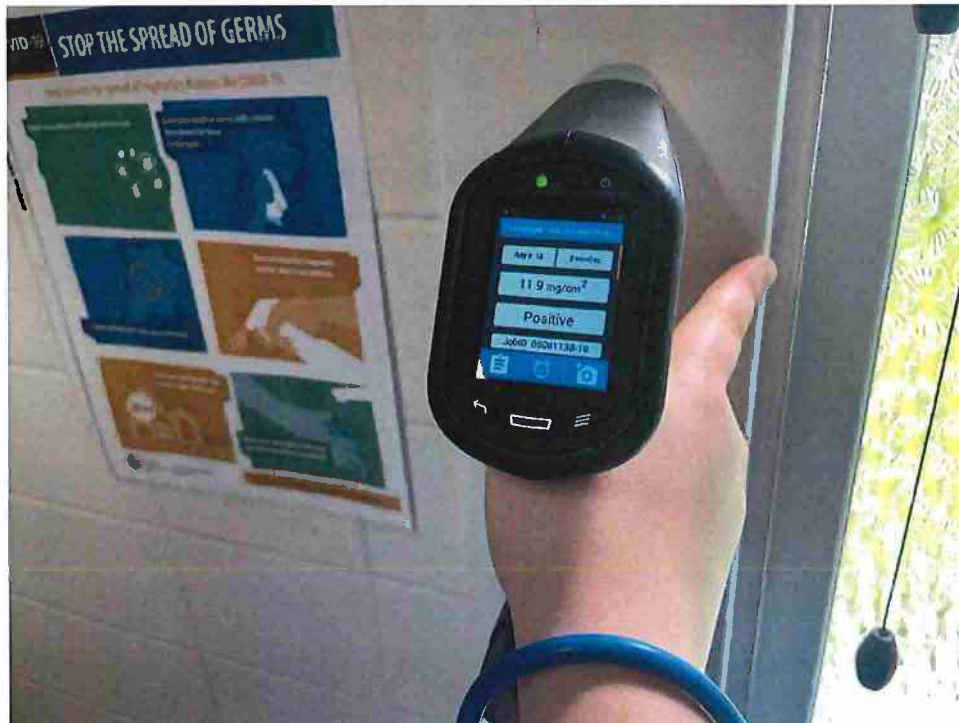
16. View of the white wood tested and identified as Lead-Based Paint

Any activity that disturbs the surfaces of lead-based paint is regulated by OSHA and requires employers to provide proper personal protective equipment (PPE) and ensure that their employees know how to implement lead-safe practices during disturbance per Environmental Protection Agency (EPA) Lead Safe Work Practices.

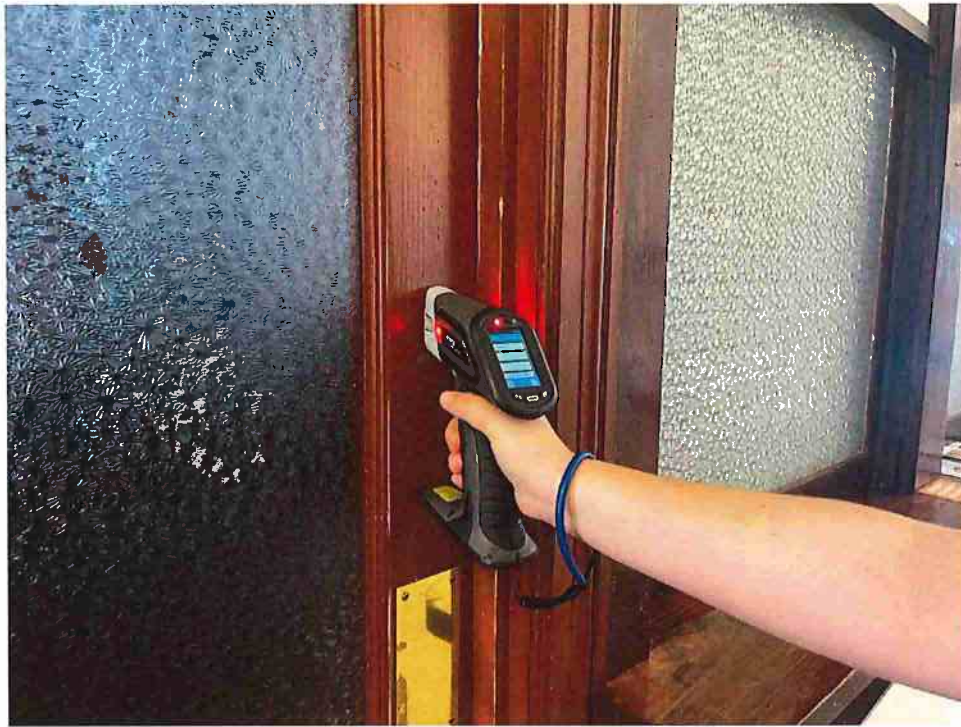
17. Typical view of the brown door components being tested for Lead-Based Paint

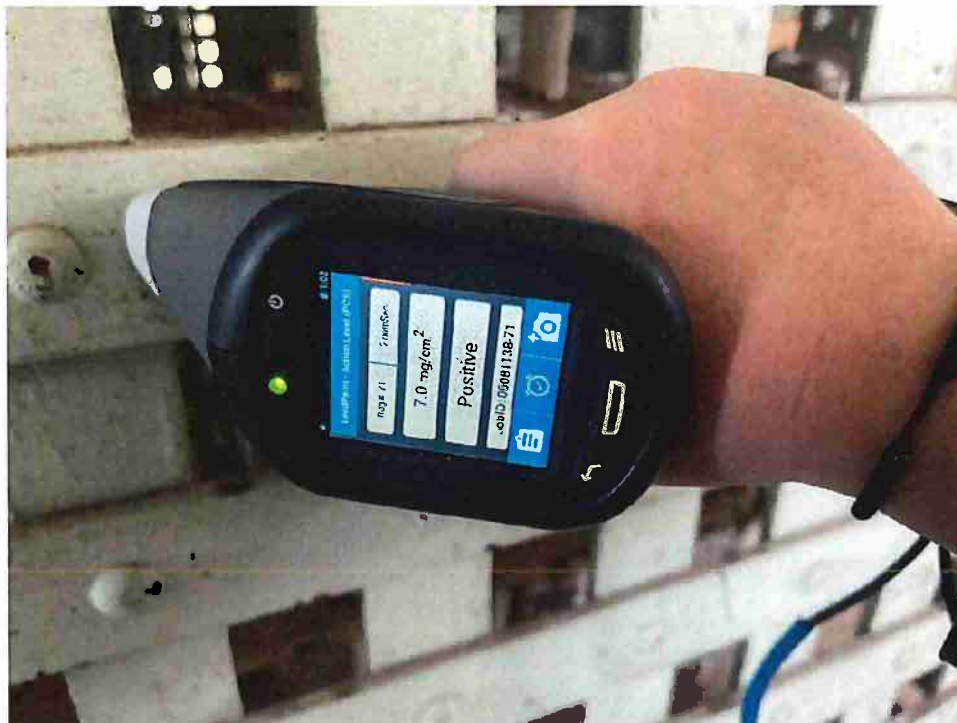
| Reading # | Date | Time | Result | Pb | Room | Side | Component | Substrate | Color | Condition |
|---|---|---|---|---|---|---|---|---|---|---|
| 69 | 6/8/2023 | 13:00:17 | Positive | 2.8 | 3rd Floor Jail | D | Jail Cell | Metal | White | Deteriorated |
| 71 | 6/8/2023 | 13:01:35 | Positive | 7 | 3rd Floor Jail | C | Jail Cell | Metal | White | Deteriorated |

18. View of the white metal jail cells tested and positive for Lead – Based Paint

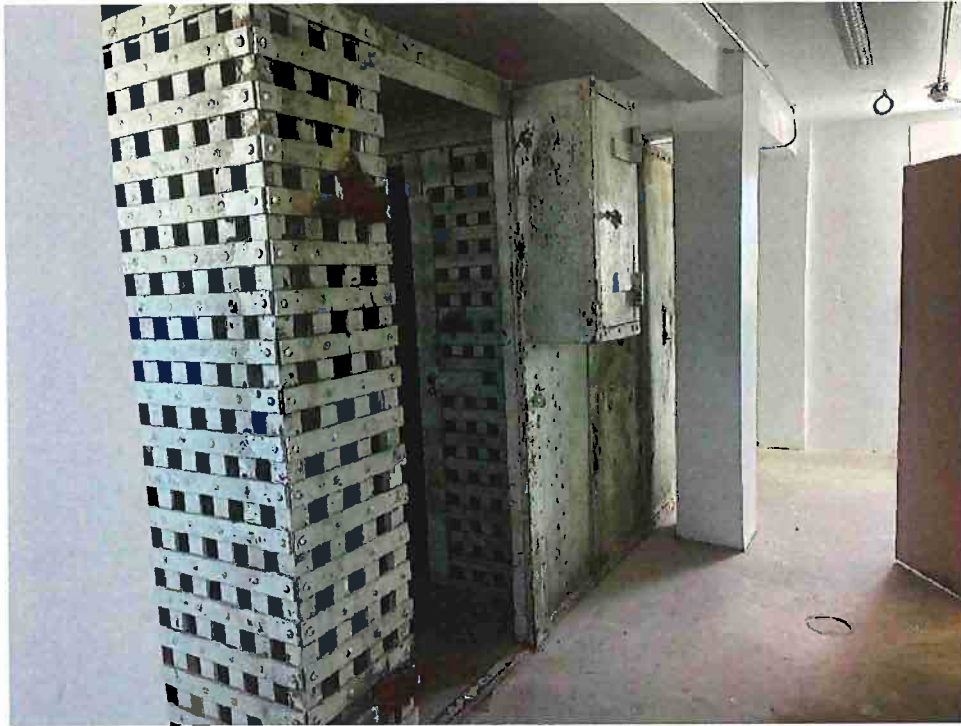
19. View of the Jail Cells

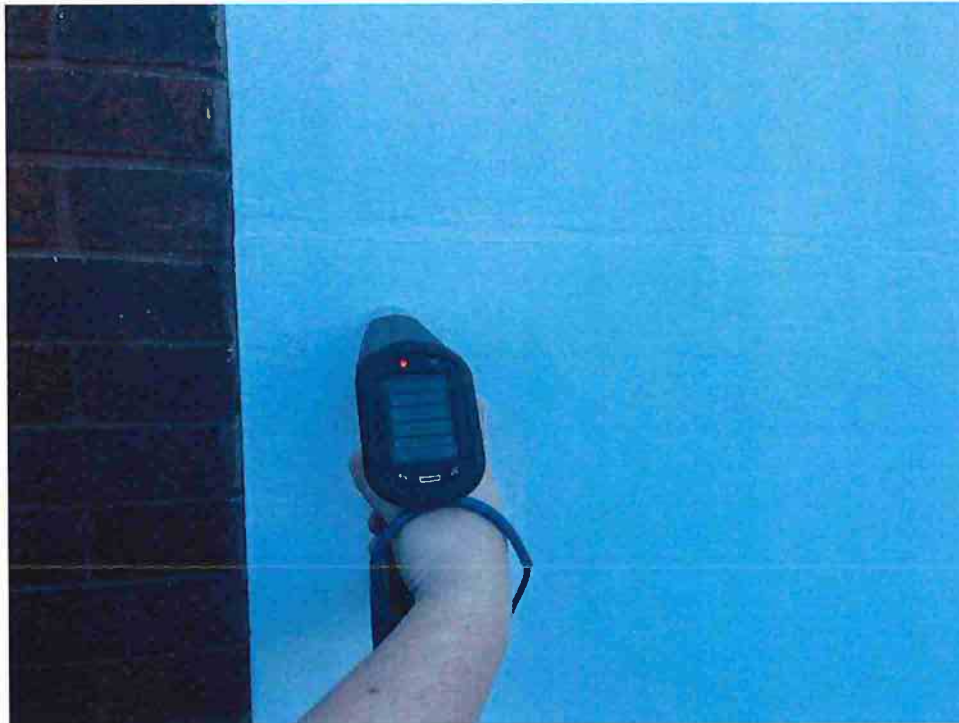
Summary: Per the RRP rules and regulations, all interior white, brown, grey, and all exterior white building components must be considered POSITIVE for lead-based paint. A full list of the XRF's results can be viewed in the appendices.

20. Typical view of the white exterior building components tested for Lead-Based Paint
